WOOD GERRY HOUSE
62 PROSPECT ST., PROVIDENCE, RI 02906

RHODE ISLAND SCHOOL OF DESIGN

LANDSCAPE MASTER PLAN

NOVEMBER 16, 2015

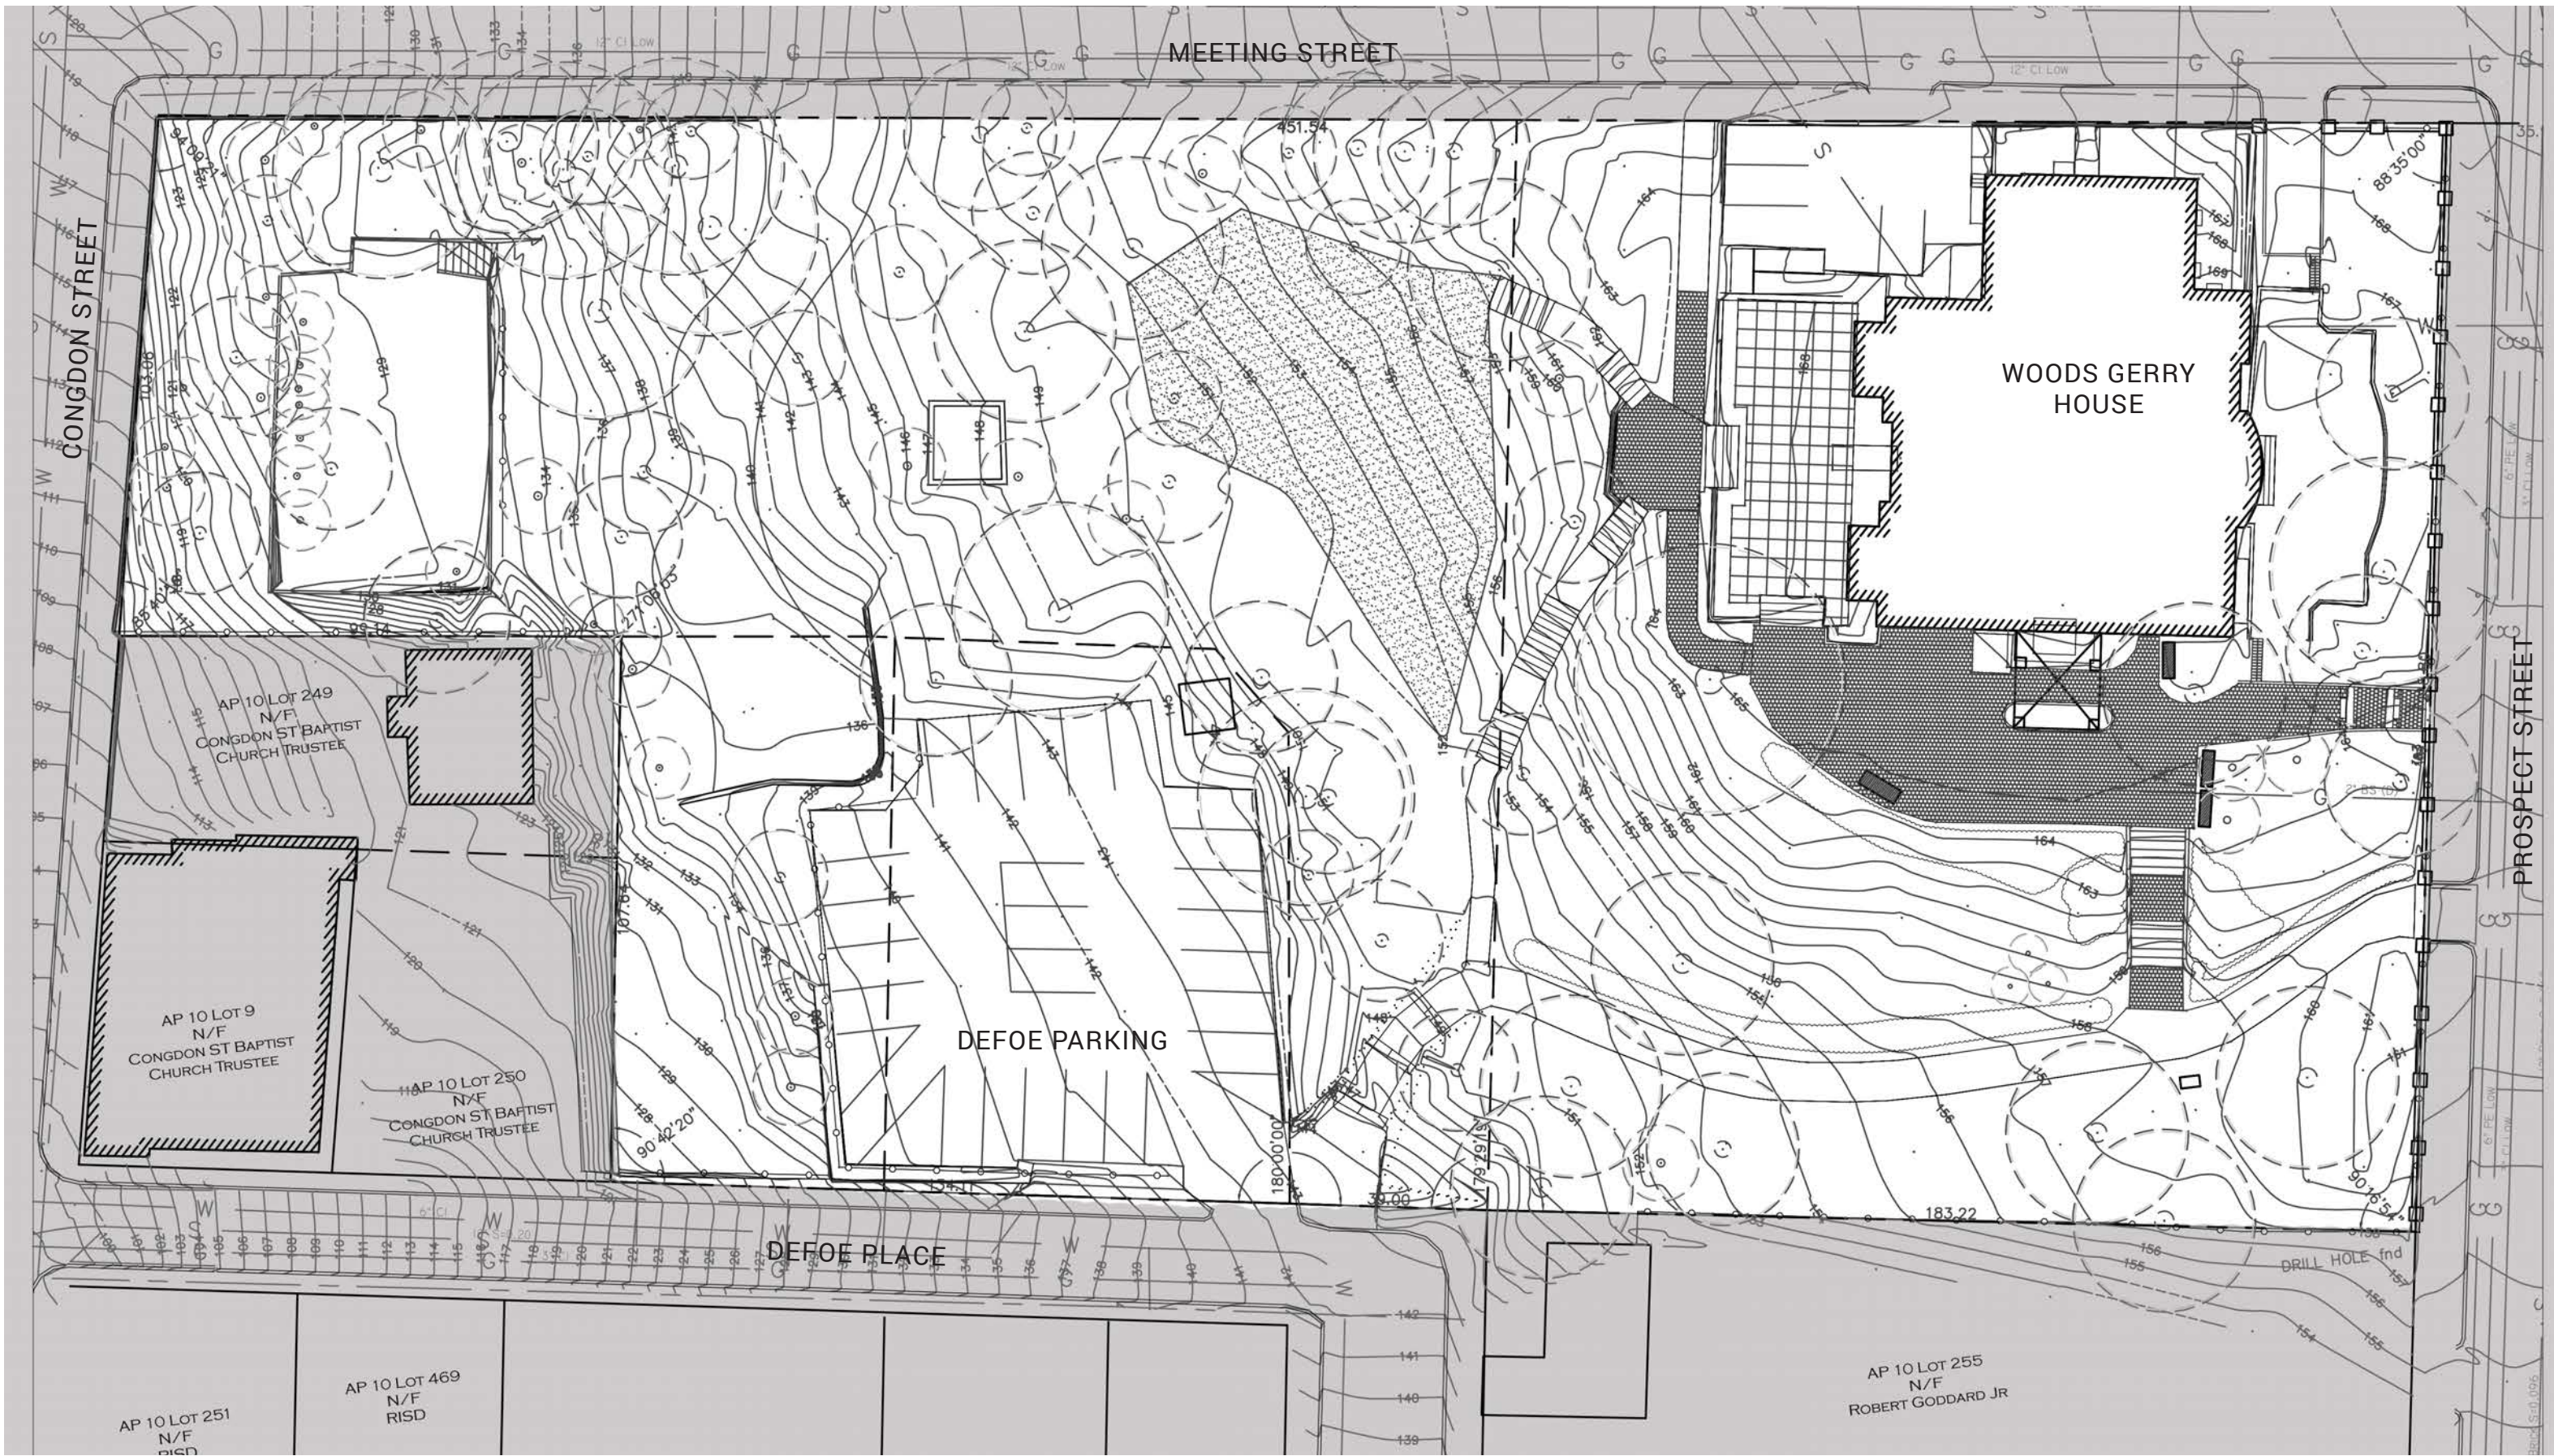
OVERALL EXISTING CONDITIONS

- (A)** Handicap Ramp not ADA compliant. Edge protection insufficient. No guardrail protecting landing from drop off. Inadequate parking lot striping and arrangement.

- (B)** Stairs do not have handrails. Concrete is deteriorating.
- (C)** Existing guardrail does not meet code for height or bar spacing.
- (D)** Stairs do not have handrails. Concrete is deteriorating. Dangerous edge condition on downhill side.

- (E)** Gravel is eroding around bluestone stepping stones creating a tripping hazard.
- (F)** Asphalt is sunken against the granite steps creating a tripping hazard.

- (G)** Stairs do not have handrails.
- (H)** Bluestone and brick paving is uneven and needs to be reset.
- (I)** Entry stairs uneven and do not meet code.

- (J)** Brownstone stairs are deteriorating, have inconsistent risers and do not have a handrail. Cheek walls are failing.
- (K)** Small, uneven stairs pose tripping hazard. Walkway above stair is too steep.

- (L)** No handrail.
- (M)** Door has no exterior handle. No edge protection on ramp. No exterior landing outside of door.
- (N)** Newer concrete walk exceeds ADA ramp slopes.

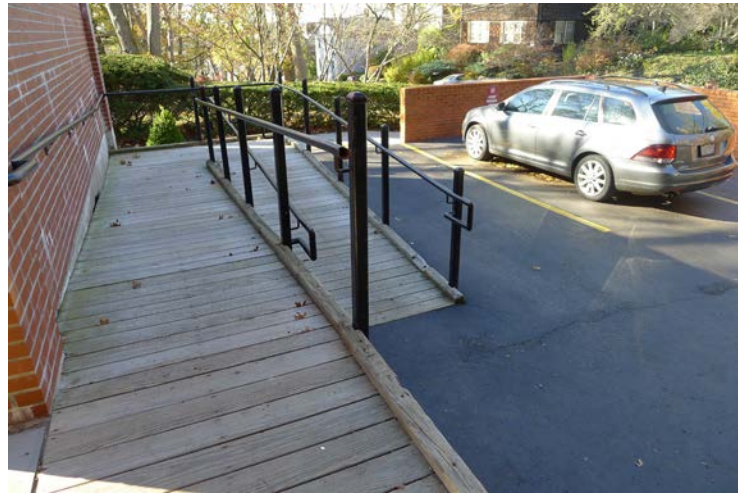
A Handicap Ramp not ADA compliant

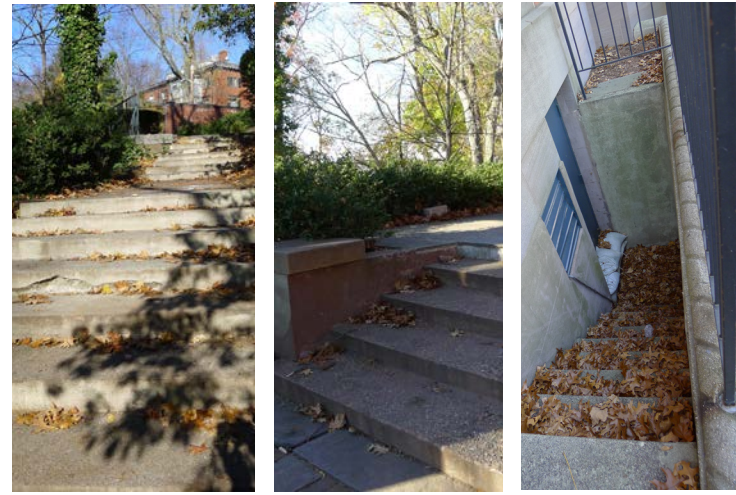
B+G+L Stairs do not have handrails.

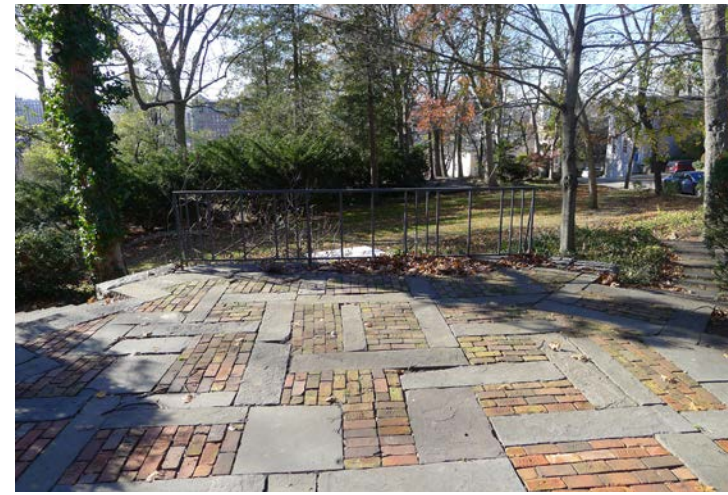
C Existing guardrail does not meet code

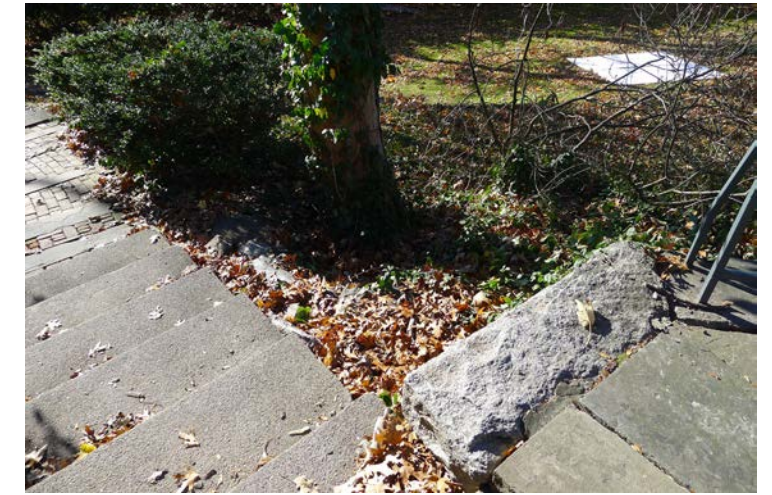
D Dangerous edge condition.

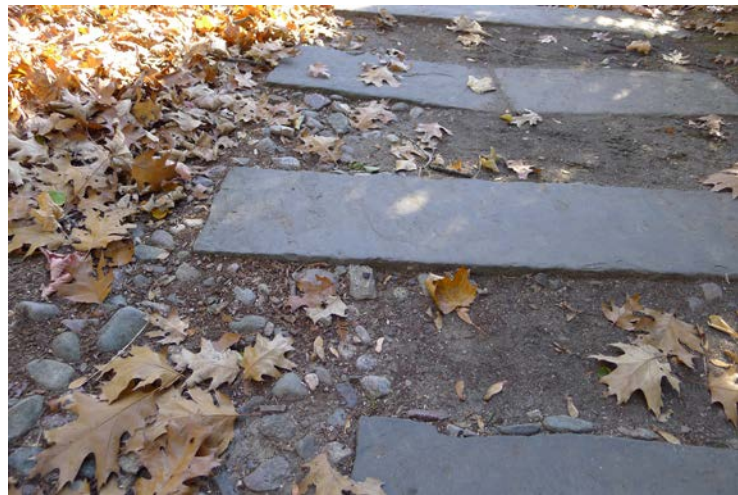
E Gravel is eroding around granite

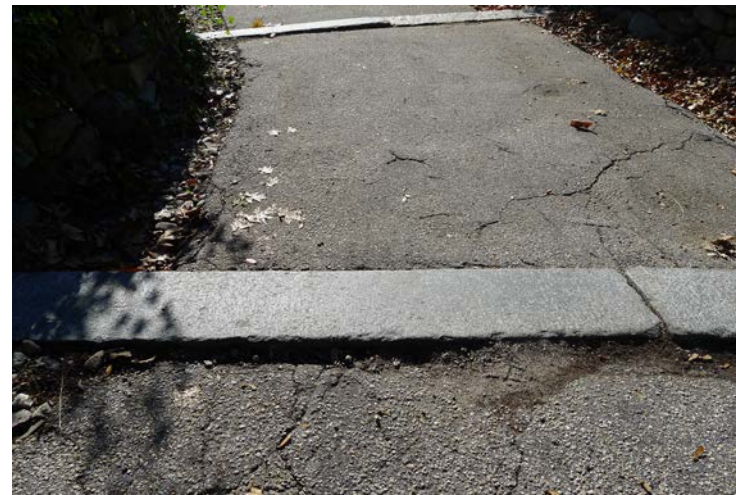
F Asphalt is sunken against granite

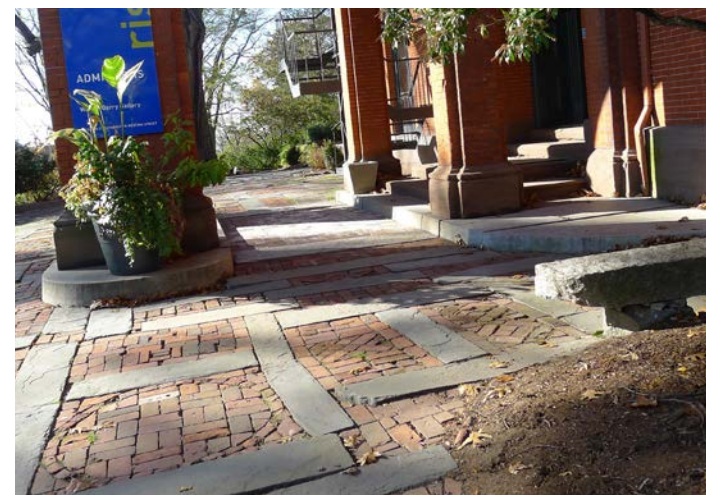
H Bluestone and brick paving is uneven

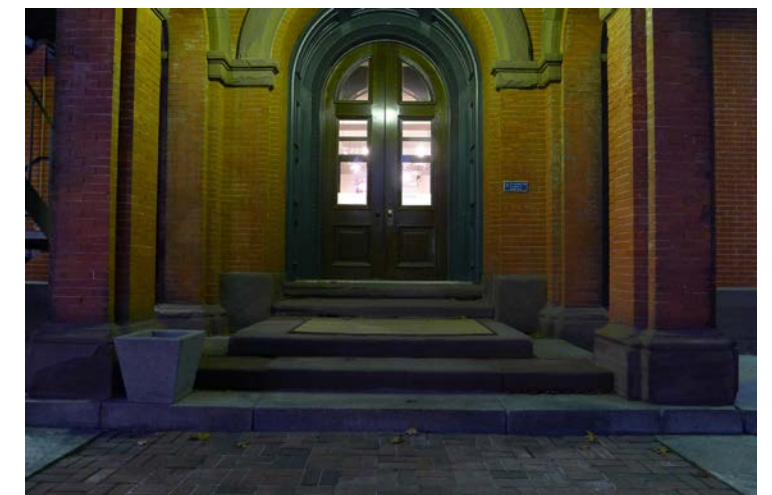
I Entry stairs are uneven

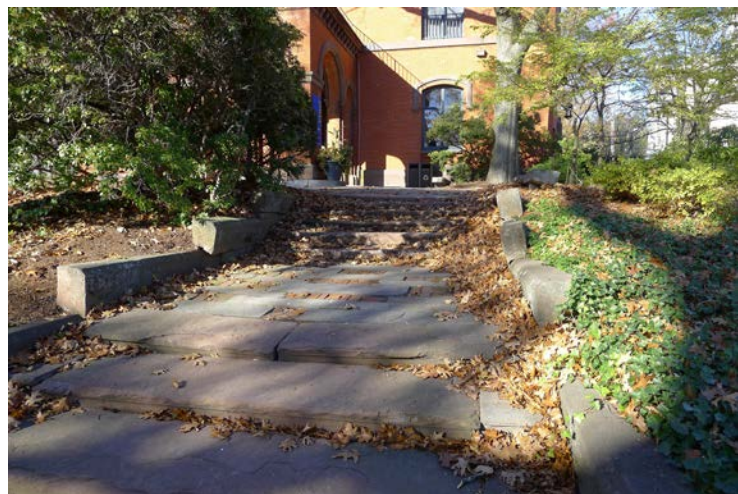
J Brownstone stairs are deteriorating

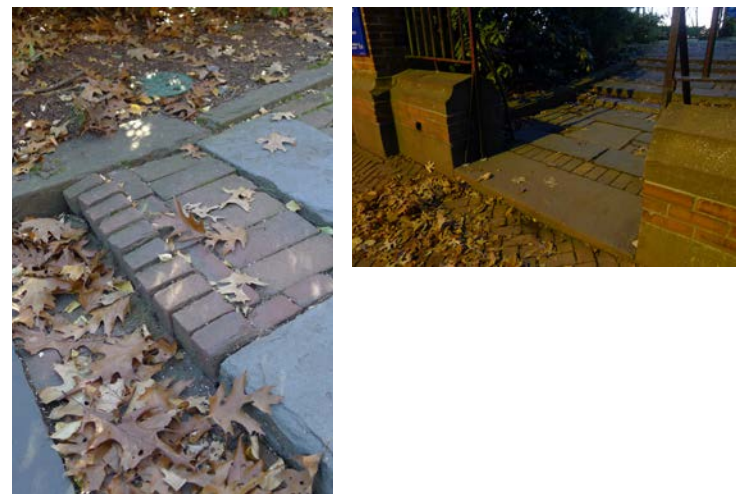
K Small uneven stairs pose tripping hazard. Too steep at top.

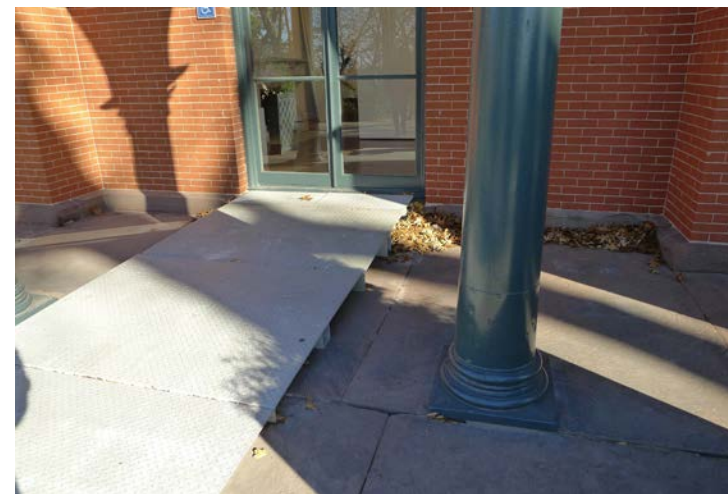
M Not ADA compliant.

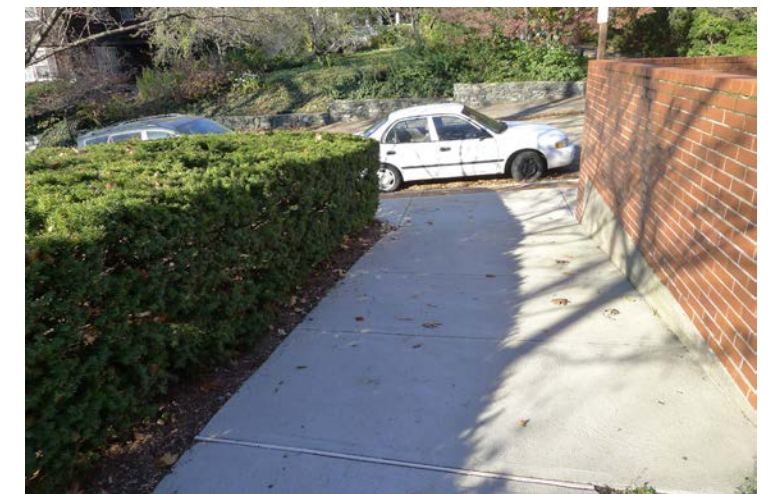
N Slopes are too steep.

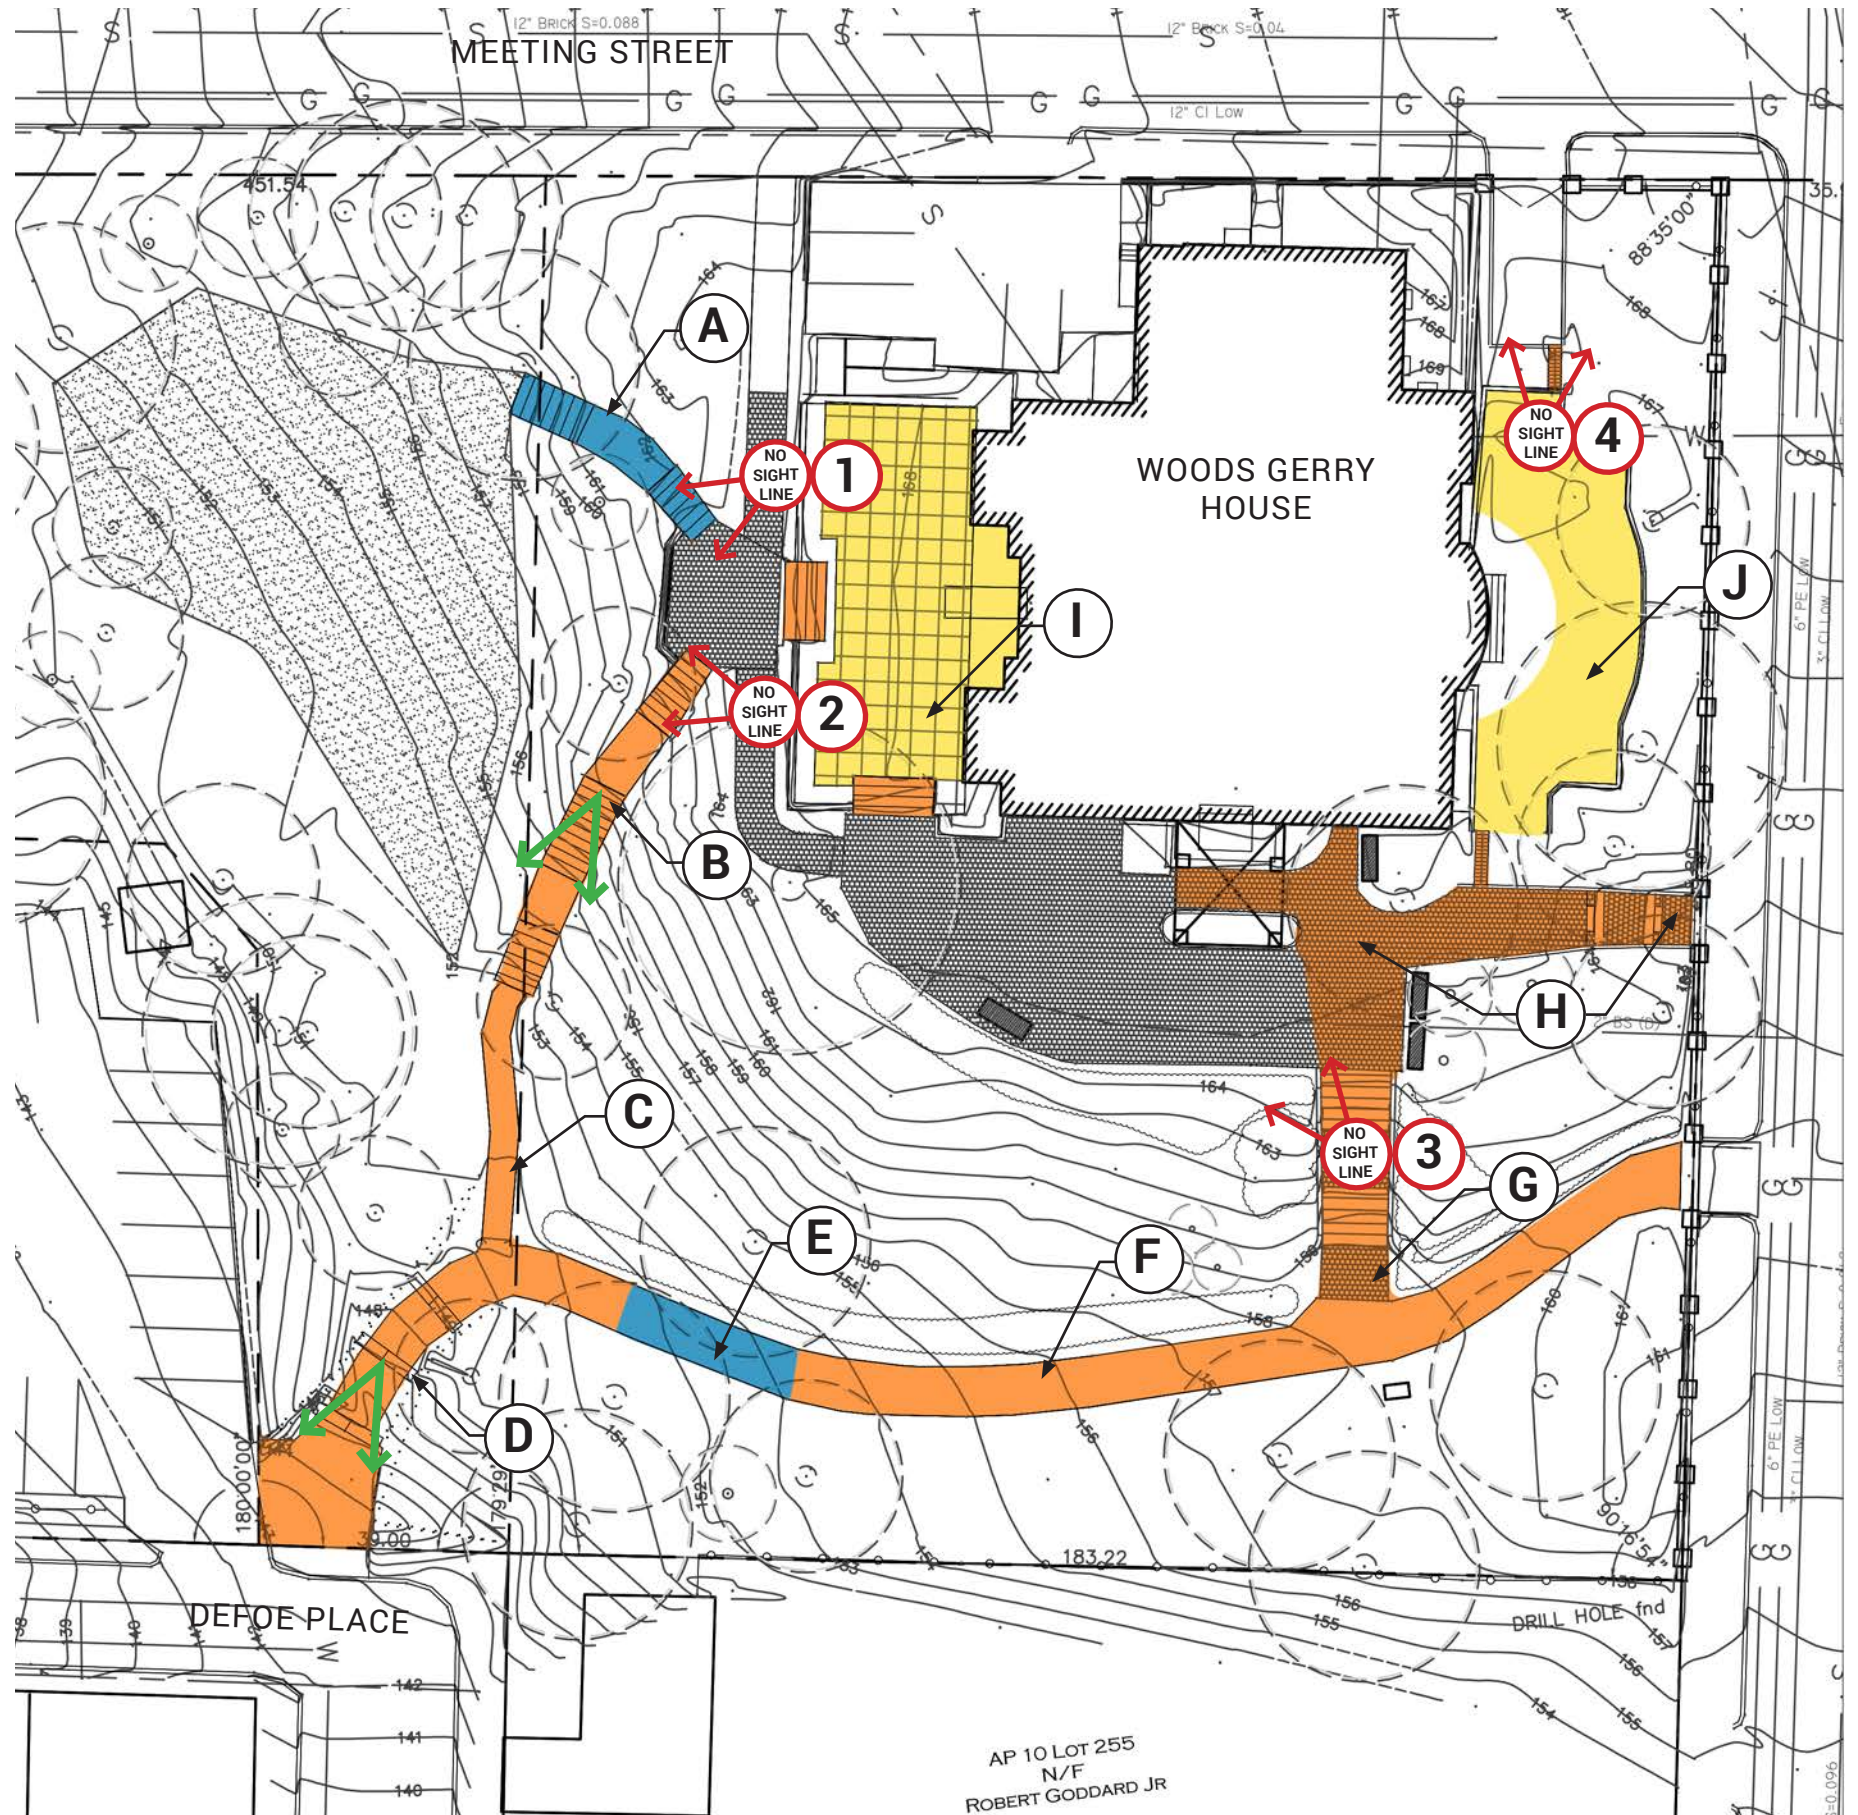
- A** Lighting in trees creates maintenance and safety problem. Lighting is too high.
- B** No lighting on stairs. Parking lot light is blinding as you approach second set of stairs from the top.
- C** No lighting along path.
- D** Existing lighting in trees is broken. Parking lot light is blinding.
- E** Lighting in trees creates maintenance and safety problem. Lighting is too high.
- F** No lighting on pathway.
- G** No lighting on stairs.
- H** Lighting levels are inadequate. No sense of entrance or destination.
- I** When windows are shuttered there is very little light on terrace and no light on handicap ramp.
- J** No lighting except historic sconce.

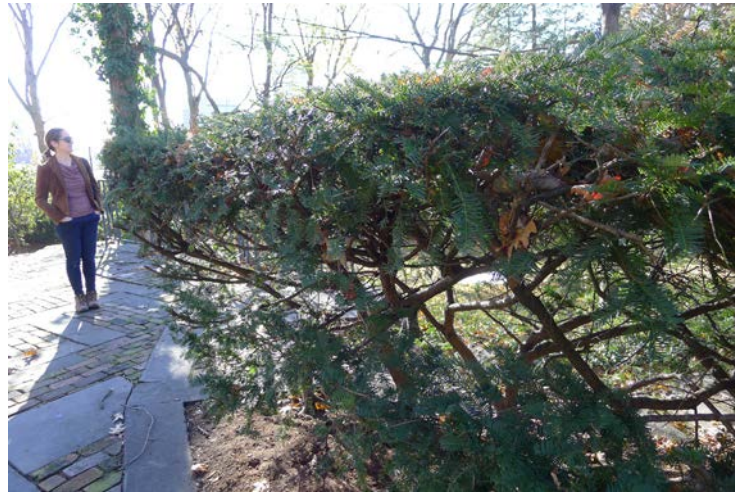
1 Blocked sight lines create dangerous hiding areas.

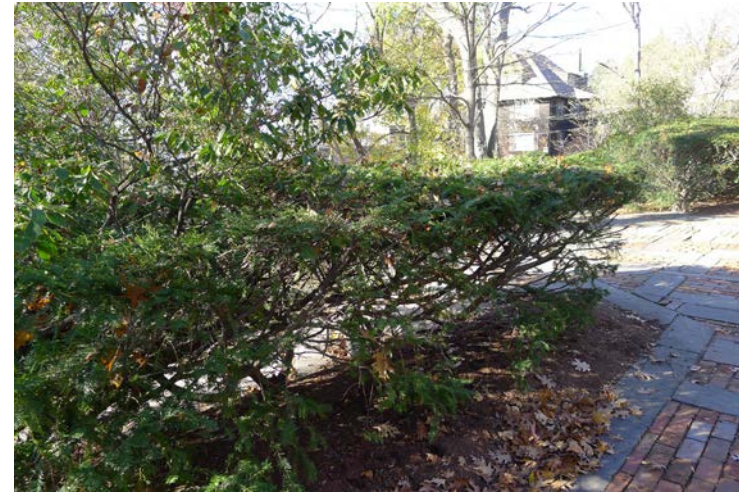
2 Blocked sight lines create dangerous hiding areas.

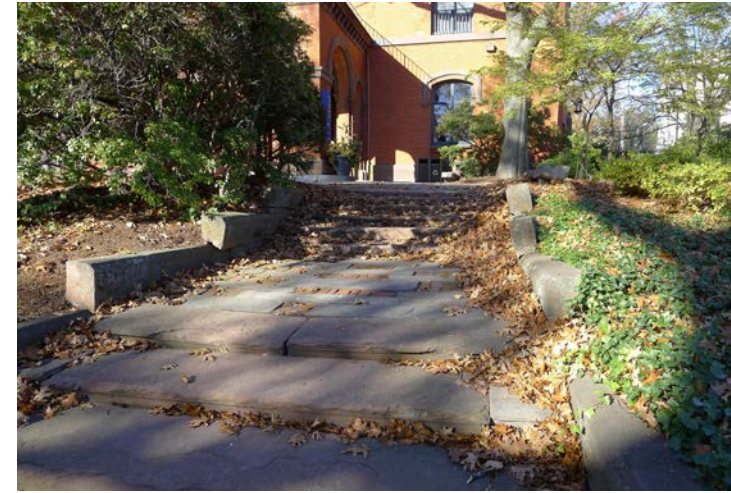
3 Blocked sight lines create dangerous hiding areas.

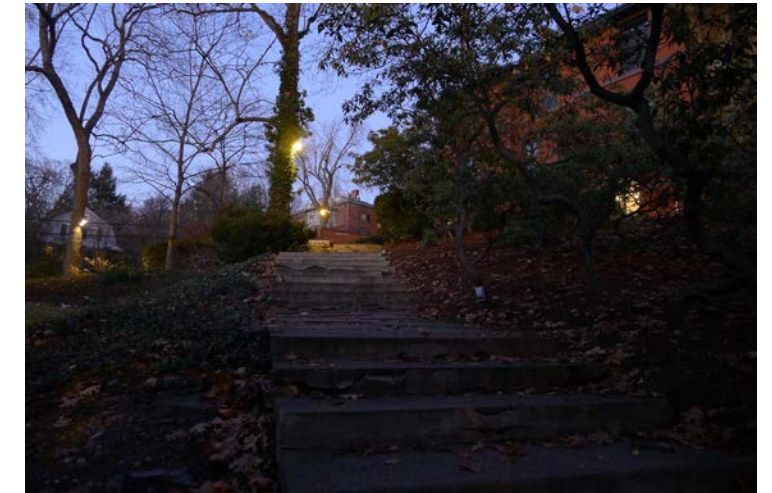
A Lighting in trees creates maintenance and safety problem. Too high.

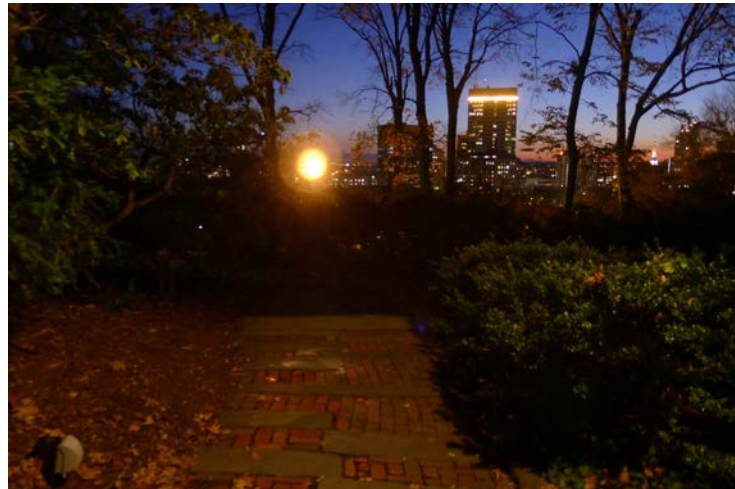
B No lighting on stairs. Parking lot light is blinding as you approach.

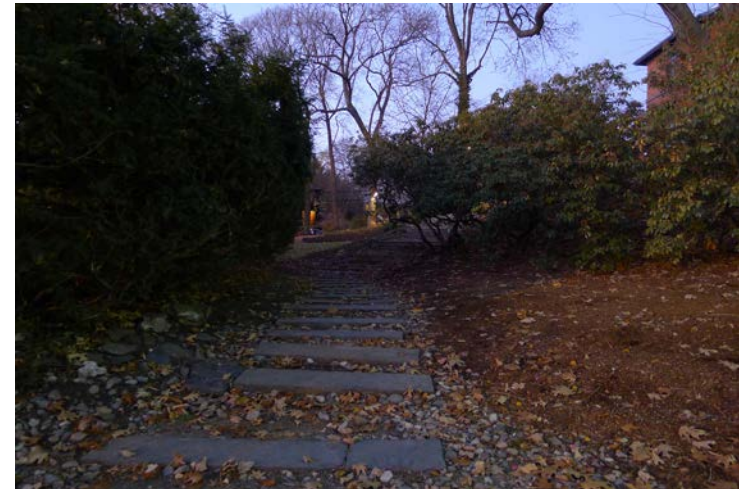
C+D No lighting along path. Existing lighting in trees is broken.

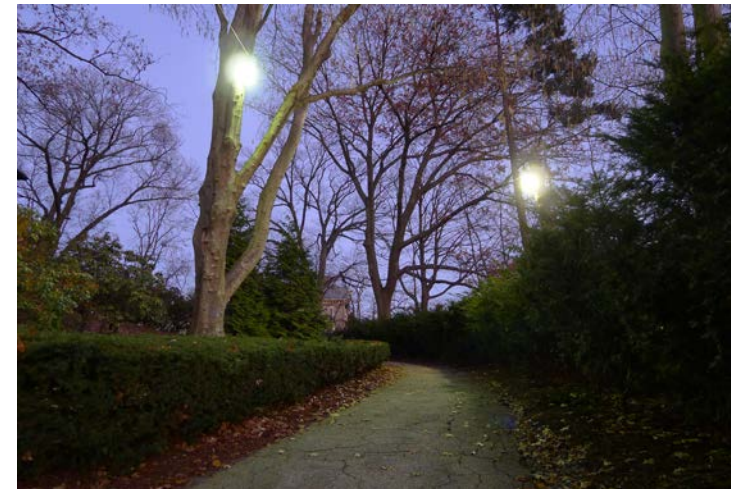
E Lighting in trees creates maintenance and safety problem. Lighting is too high.

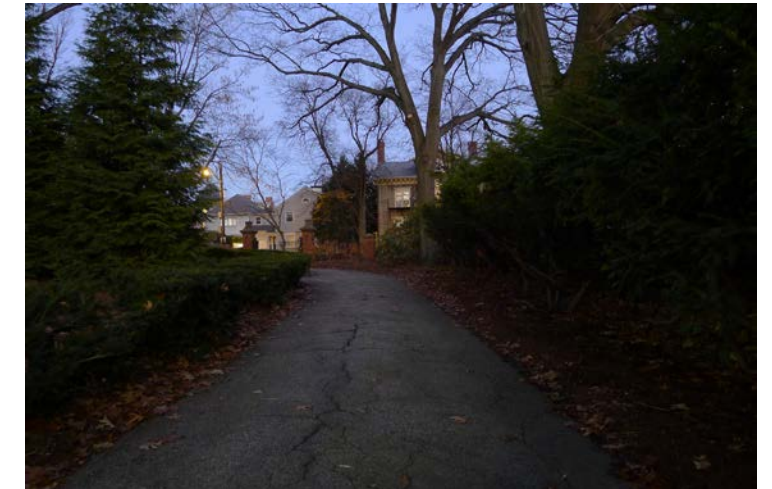
F Insufficient lighting along pathway.

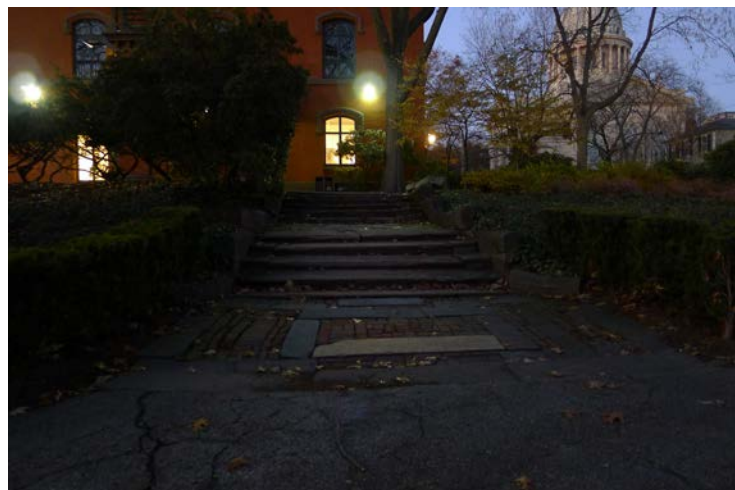
G No lighting on stairs.

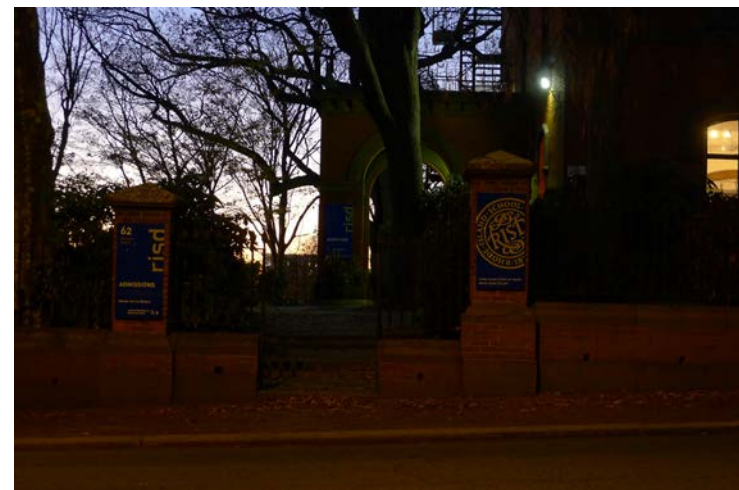
H Lighting levels are inadequate. No sense of entrance or destination.

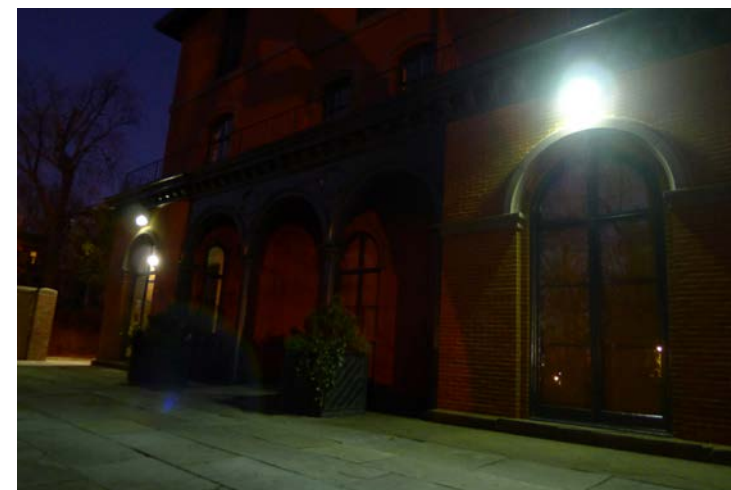
I When windows shuttered: little light on terrace, no light on handicap ramp

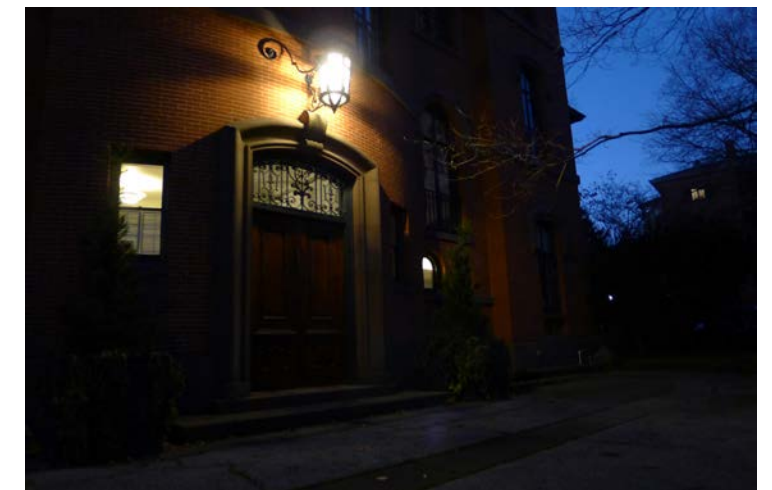
J No lighting except historic scone.

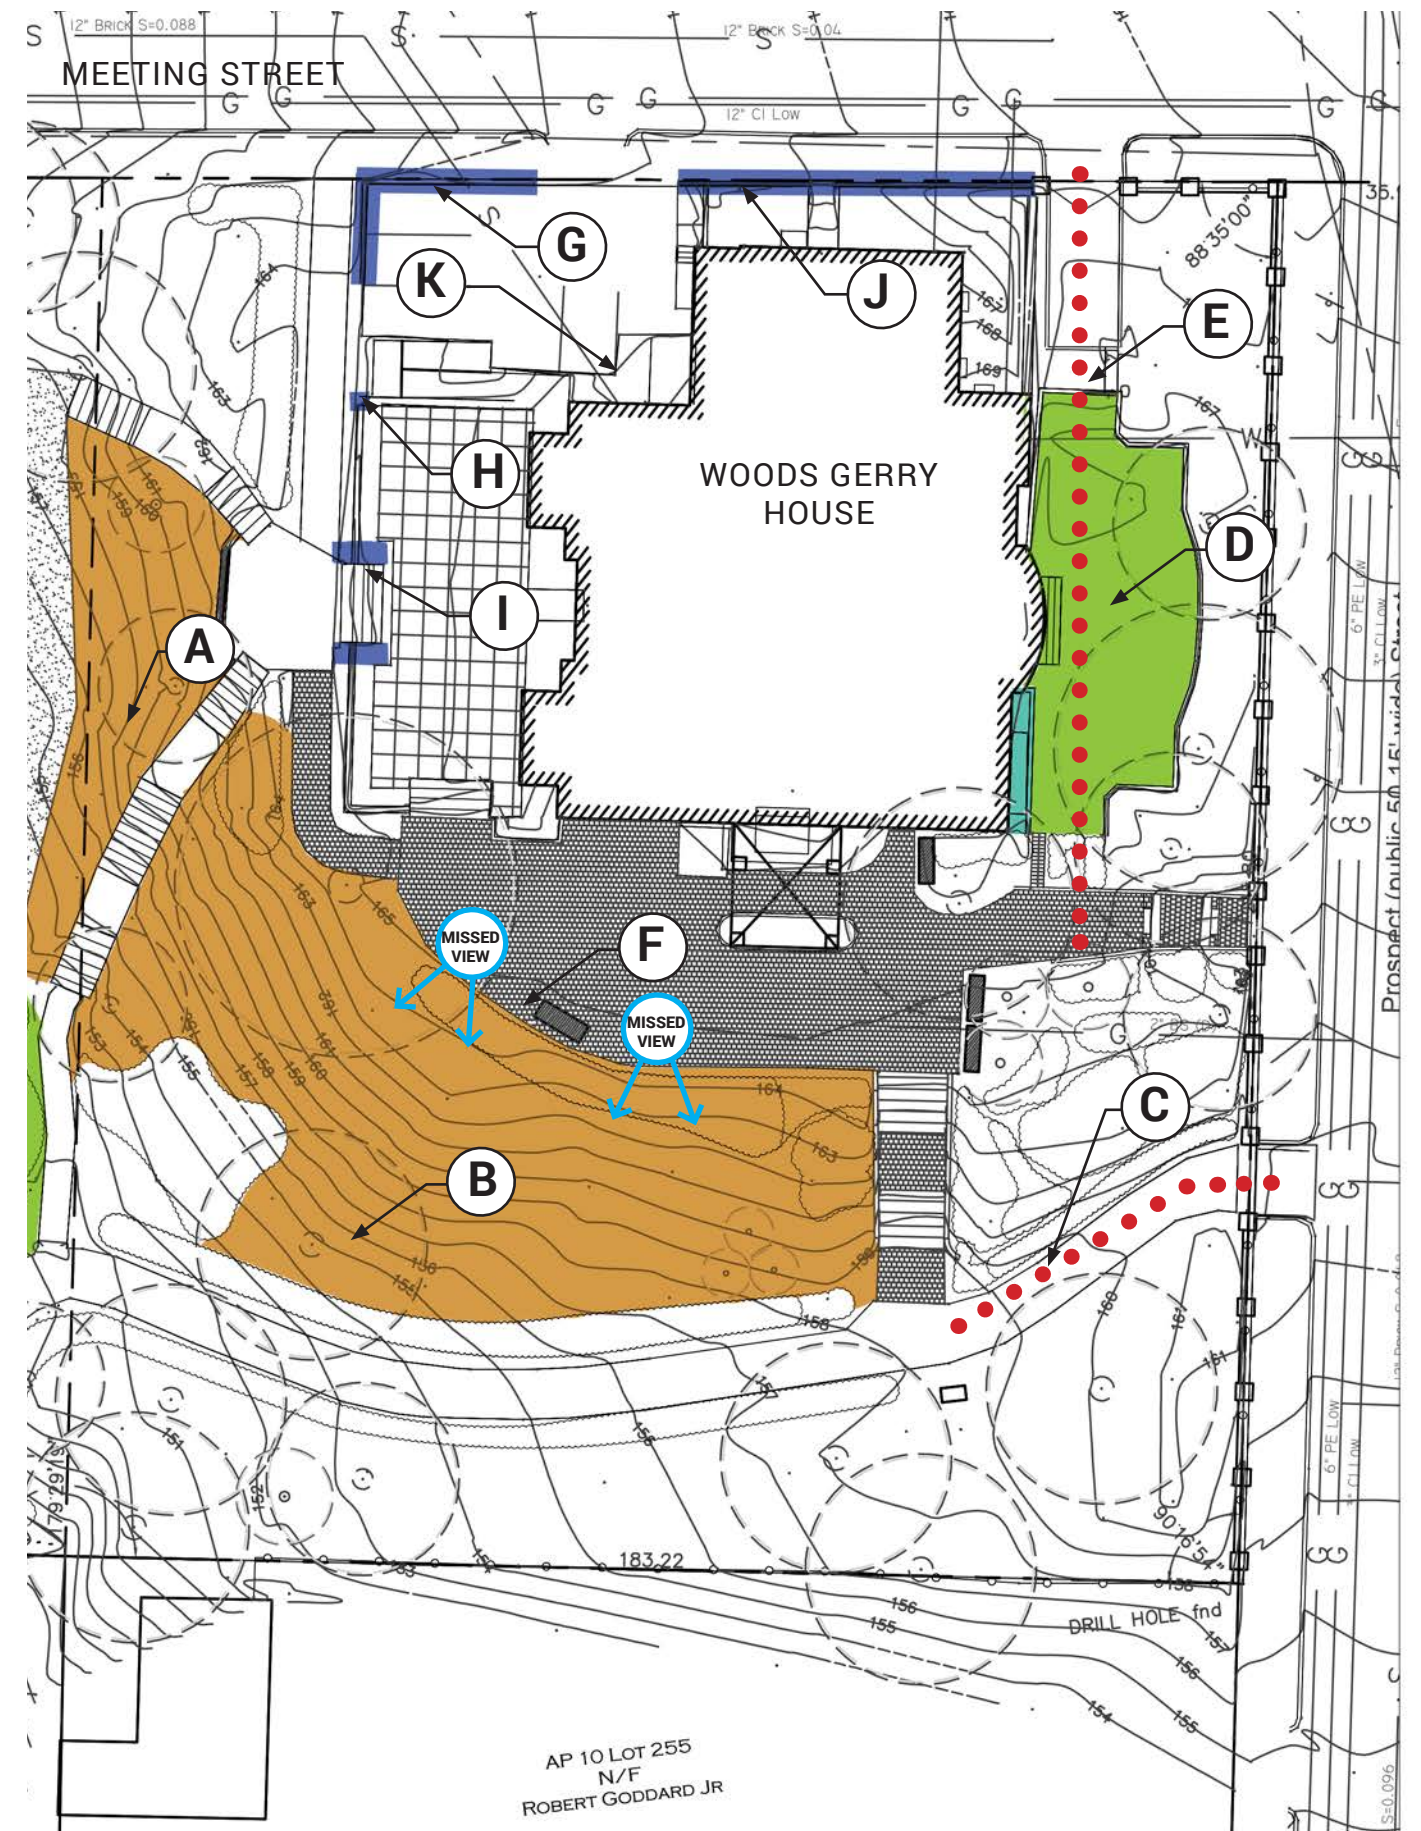
- A** Soil erosion against stairs is creating a hazard and causing deterioration of stairs. Eucalyptus damaging tree.
- B** Lack of any planting on slope is creating soil erosion issues.
- C** Closed gate limits an additional circulation route that might bring more people into the space.
- D** Plaza underutilized as a space. Asphalt inappropriate material.
- E** Plaza is cut off from site and sidewalk. Reestablishing original drive would create open area for outdoor use.
- F** Spectacular views of the city are cut off by overgrown yew hedge.
- G** Cap mortar has eroded and cracks in wall have become substantial
- H** Concrete cap on pillar has completely eroded.
- I** Cheek wall on stairs have cracks and previous repair in failing.
- J** North brick wall needs cleaning and repointing
- K** HC parking needs to be reconfigured.

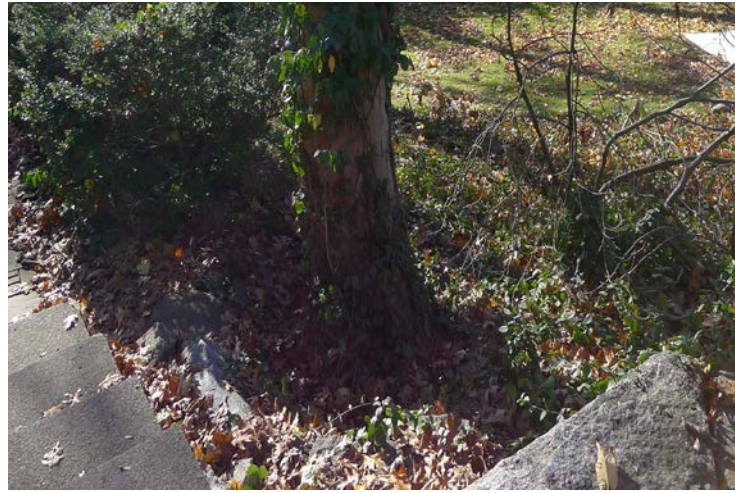
A Erosion against stair edge. Euonymus damaging trees.

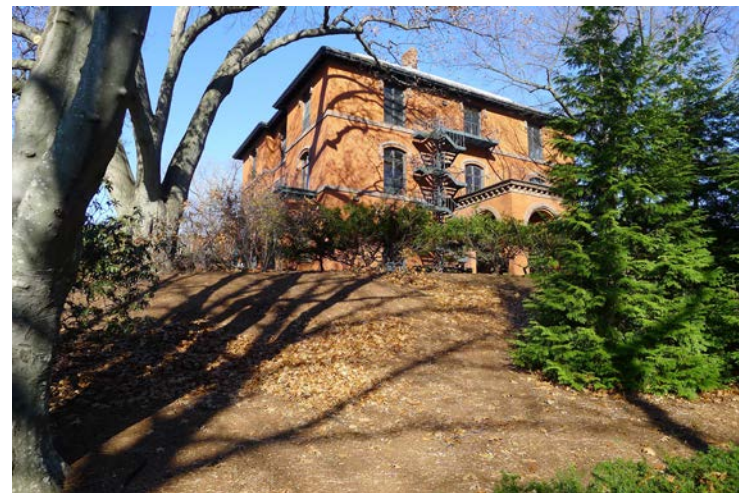
B Bare soil creates erosion issues.

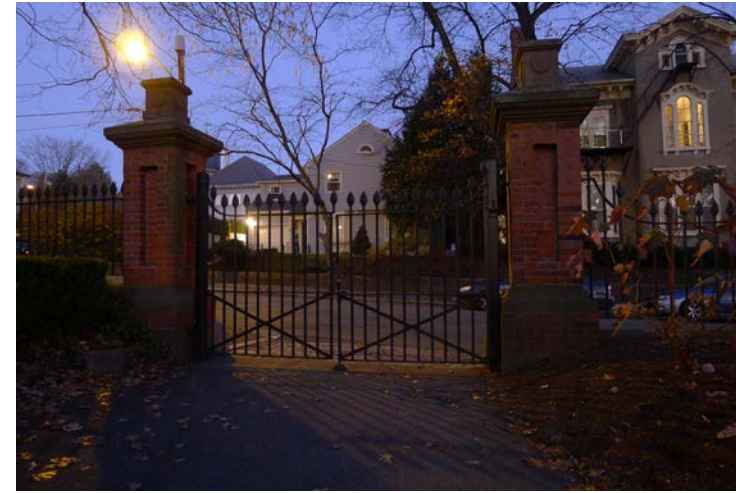
C Gate often closed and connection lost.

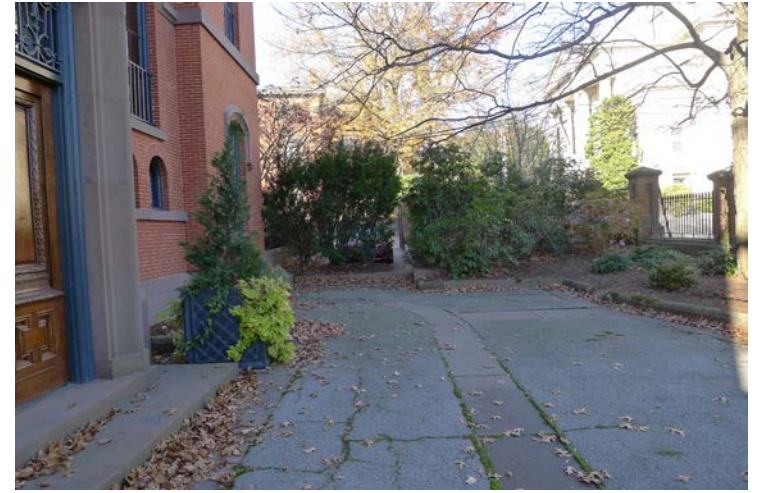
D Plaza underutilized and disconnected.

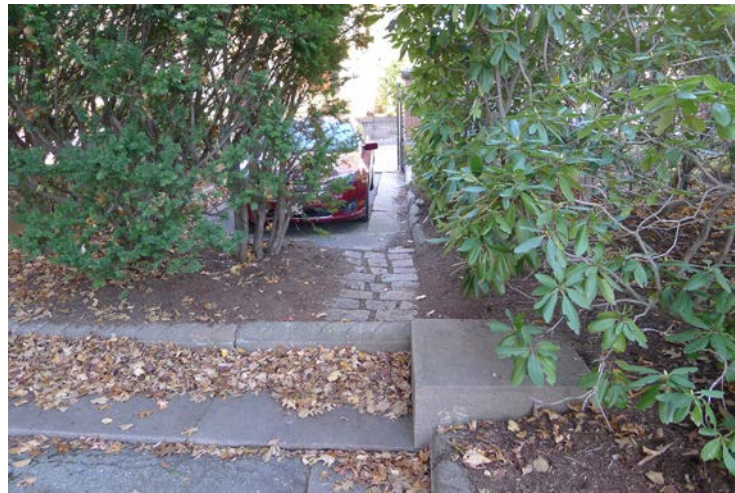
E Connection lost due to planting and lack of paving

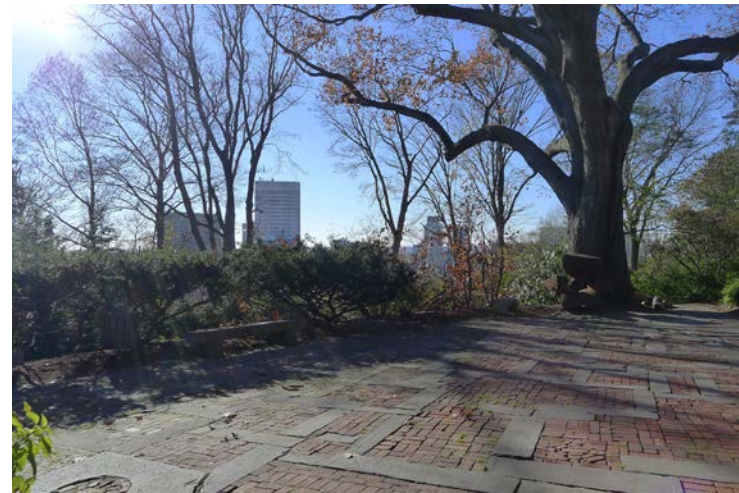
F Better view blocked by yew hedge

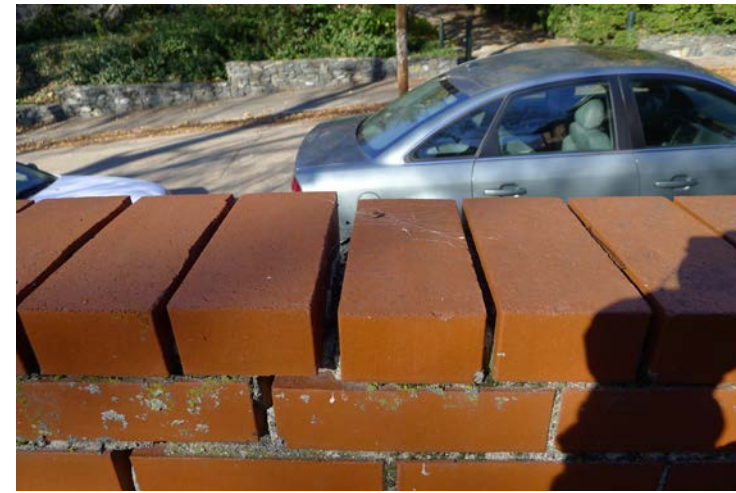
G Eroded mortar on cap

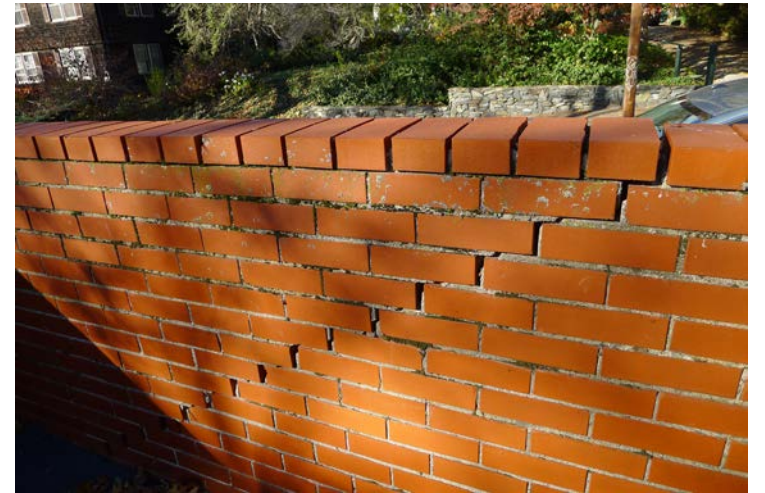
H Cracks in brick wall

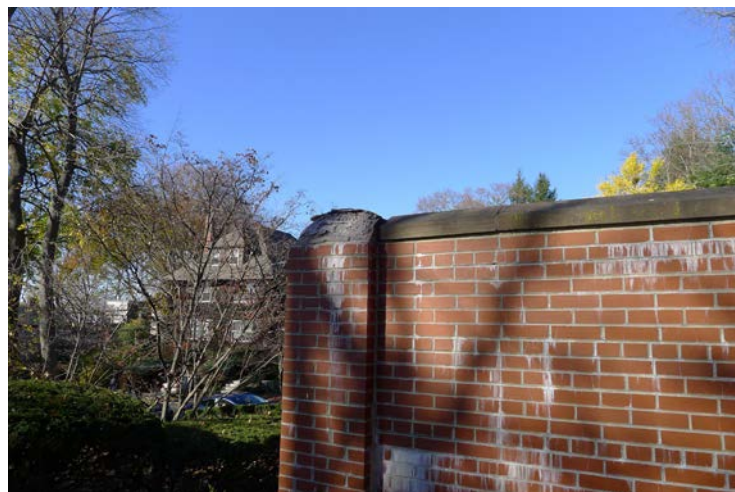
I Pillar cap eroded
