WOOD GERRY HOUSE
62 PROSPECT ST., PROVIDENCE, RI 02906

RHODE ISLAND SCHOOL OF DESIGN

LANDSCAPE MASTER PLAN

NOVEMBER 16, 2015

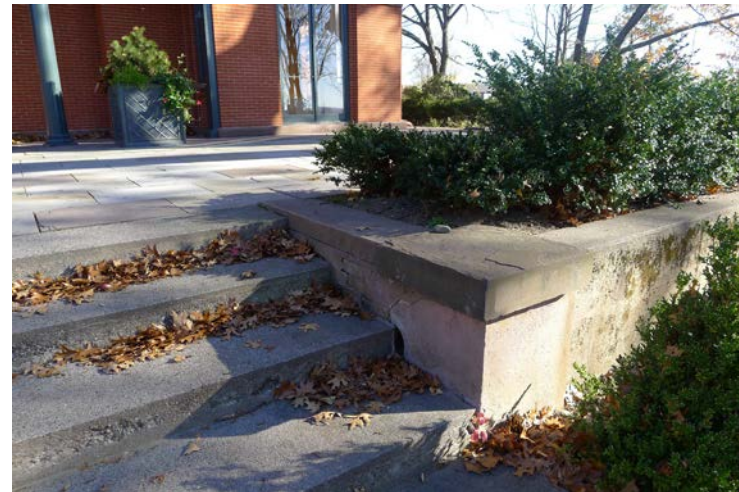
J Cheek walls on both sides of stair cracked.

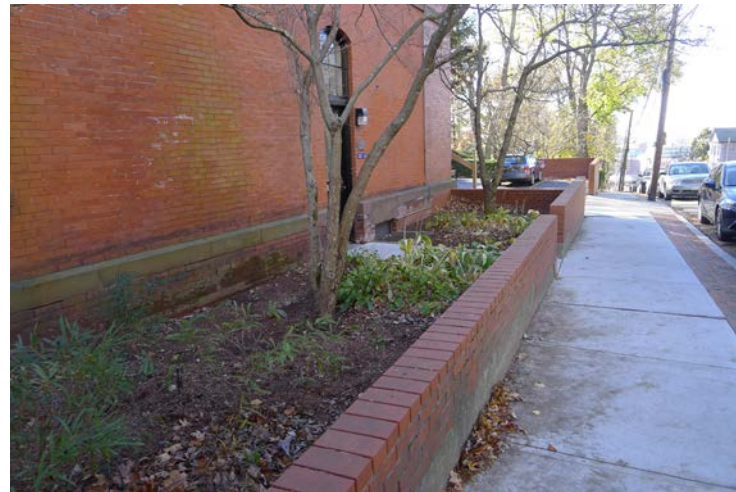
K Moss needs to be cleaned off wall and repointing as needed.

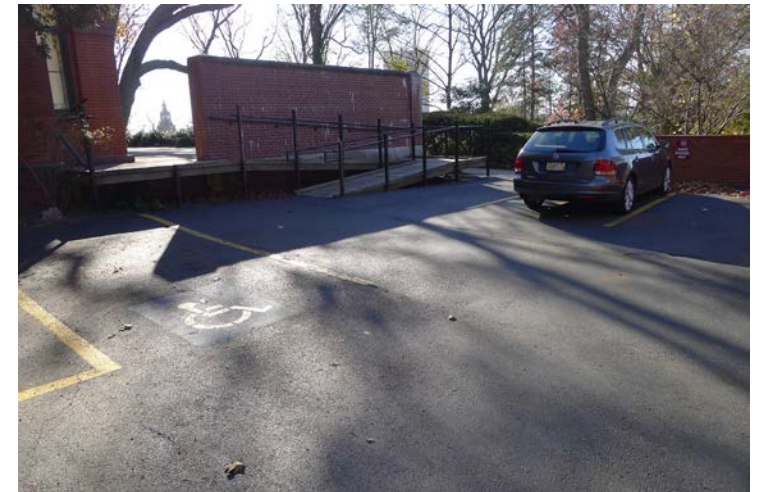
L HC parking needs to be reconfigured.

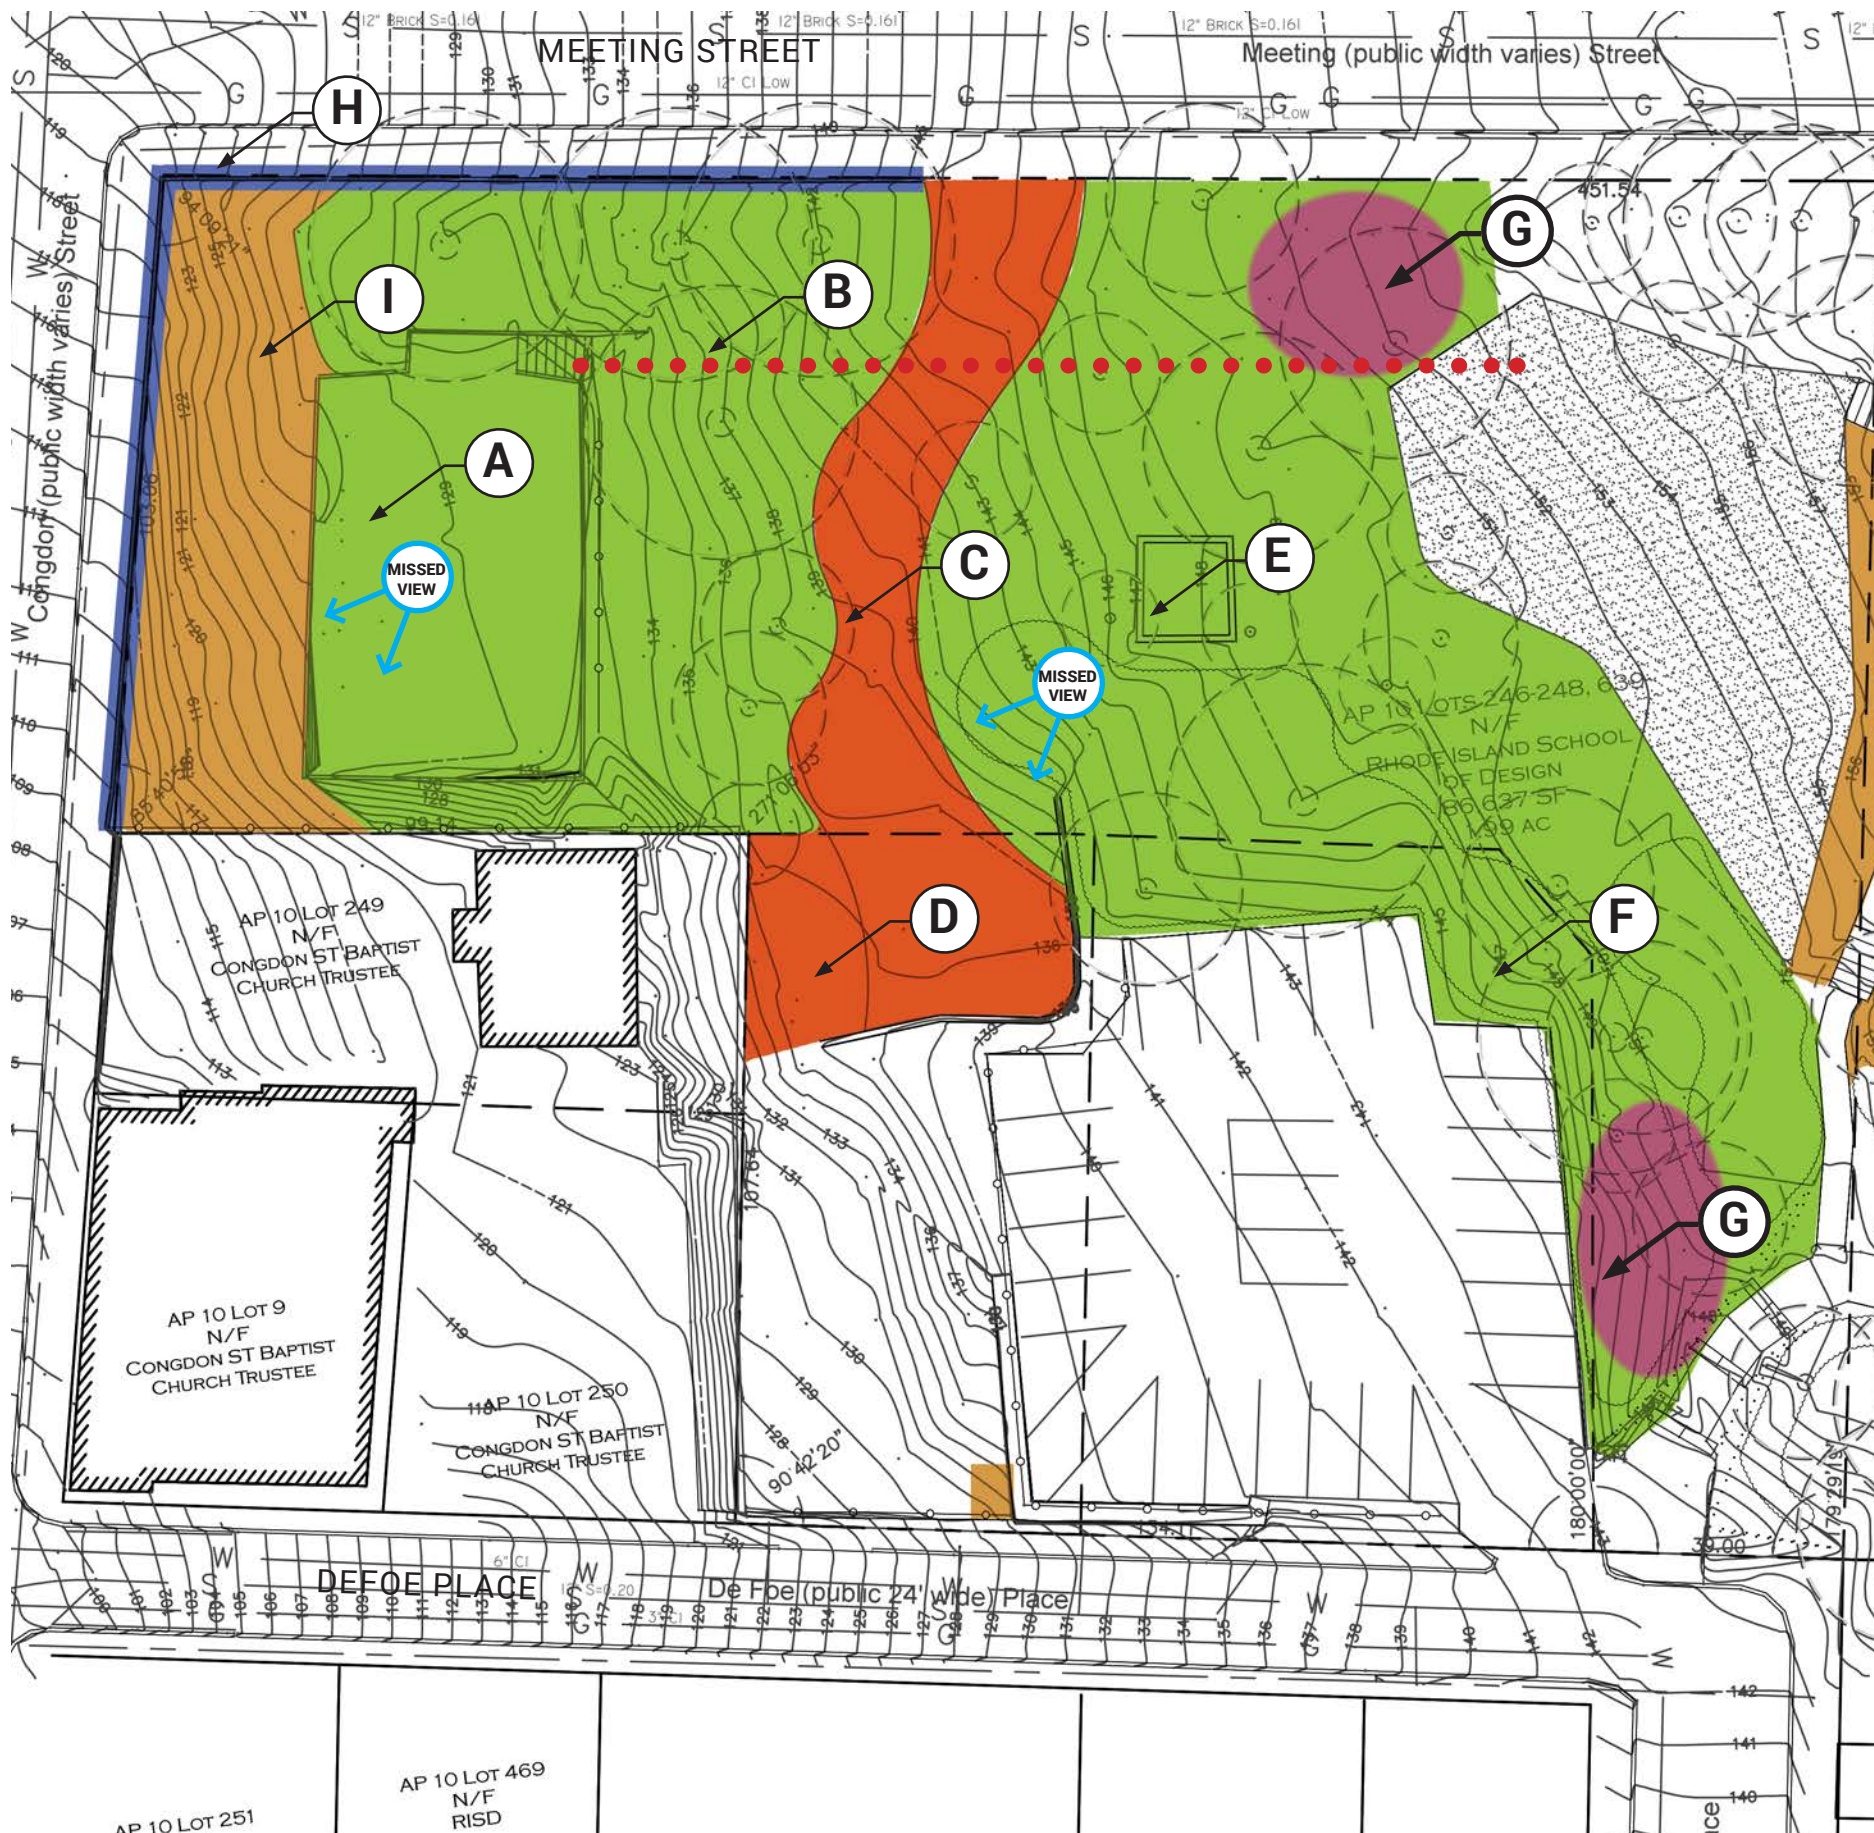
- A Terrace disconnected from the rest of the site and in poor condition
- B Soil and leaf filling on trees. Stockpiling of materials on roots of trees
- C Road bisects and cuts off site, encourages fill and dumping
- D Snow and mulch storage
- E Overgrown yews and broken stones creating unsafe conditions for informal patio
- F Salt Storage
- G Invasive Japanese Knotweed
- H Timber wall in poor condition and sharp steel posts creating unsafe conditions.
- I Erosion caused by unvegetated, steep slope.

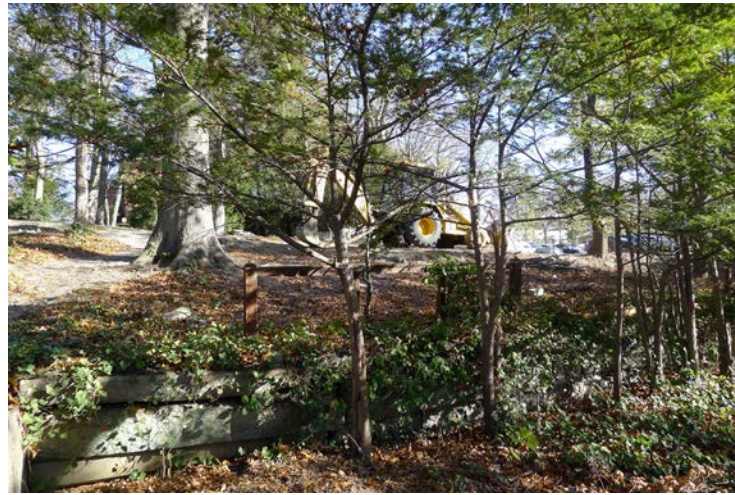
A Terrace disconnected from site and in poor condition

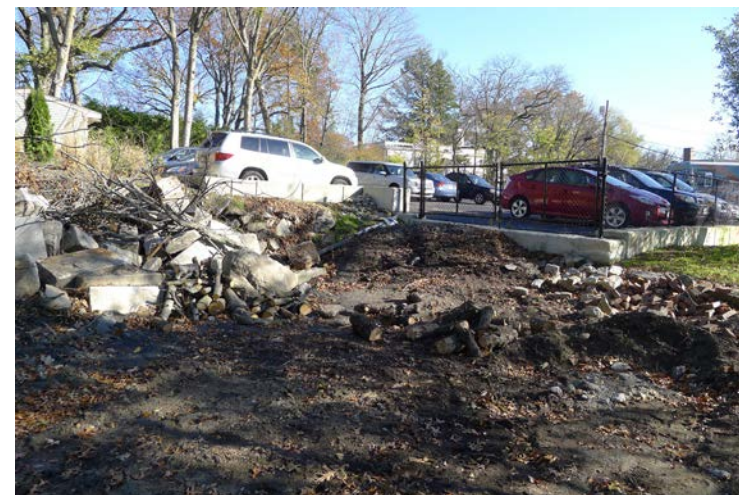
B Soil and leaf filling on trees. Stockpiling on roots of trees.

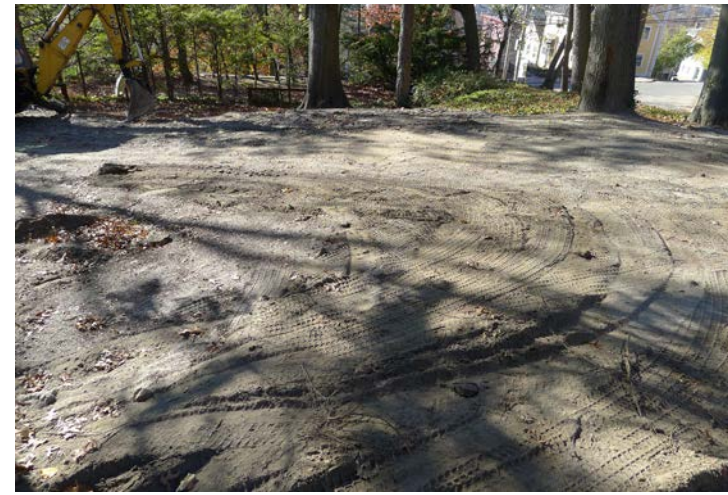
C Road bisects and cuts off site.

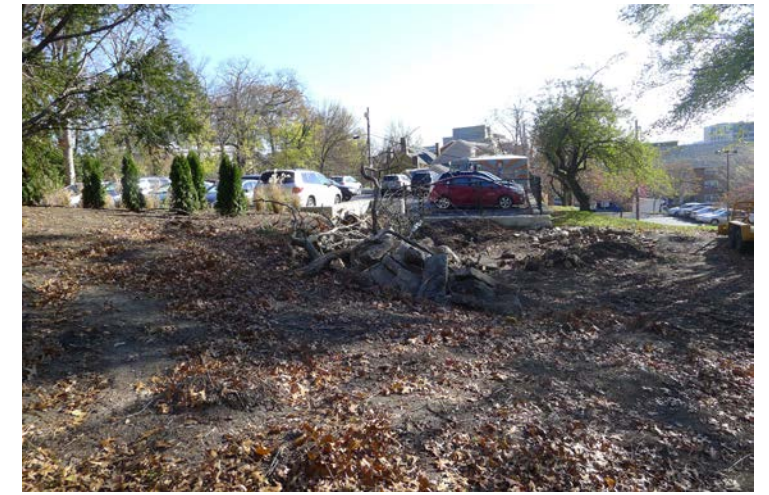
D Snow and mulch storage

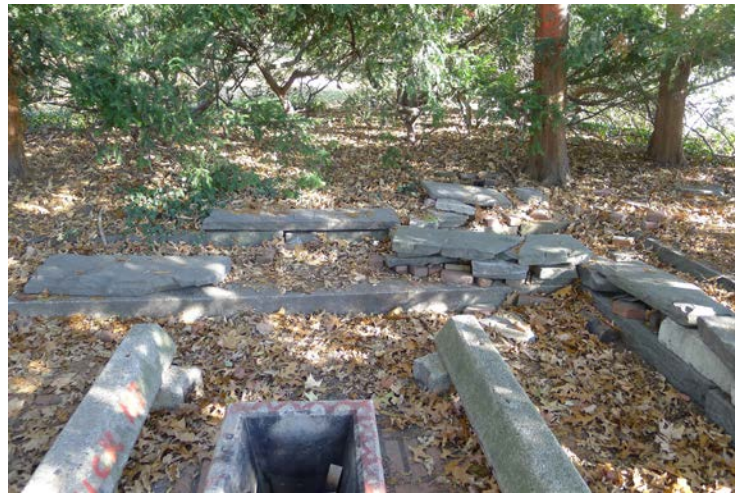
E Overgrown yews and broken stones create unsafe conditions for patio

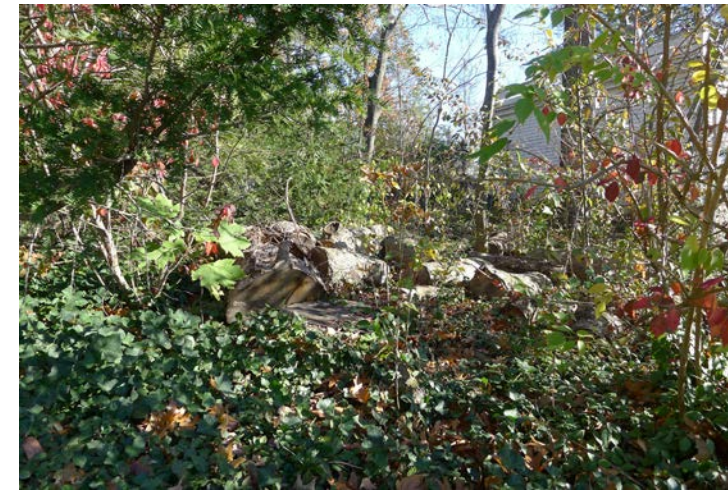
G Invasive Japanese knotweed

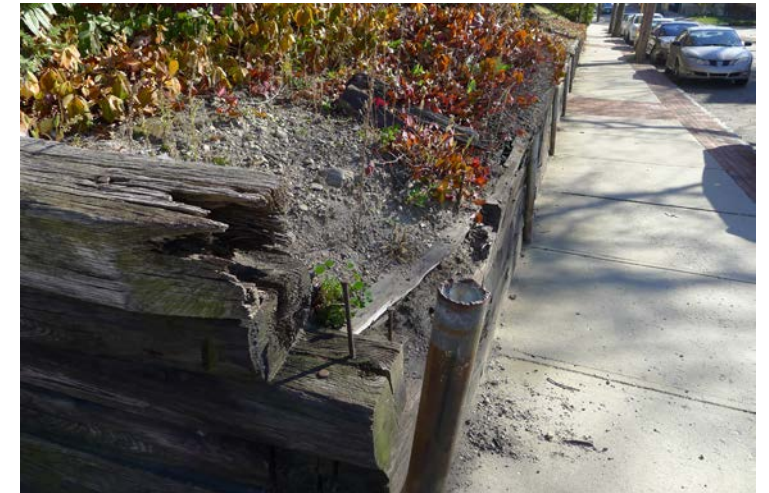
H Timber wall in poor condition. Steel posts cause safety hazard.

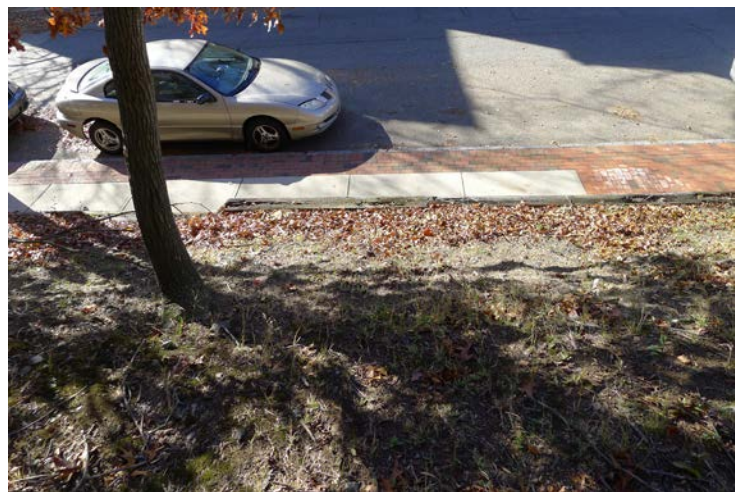
I Erosion from steep slope and lack of vegetation.
