WOOD GERRY HOUSE
62 PROSPECT ST., PROVIDENCE, RI 02906

RHODE ISLAND SCHOOL OF DESIGN

LANDSCAPE MASTER PLAN

NOVEMBER 16, 2015

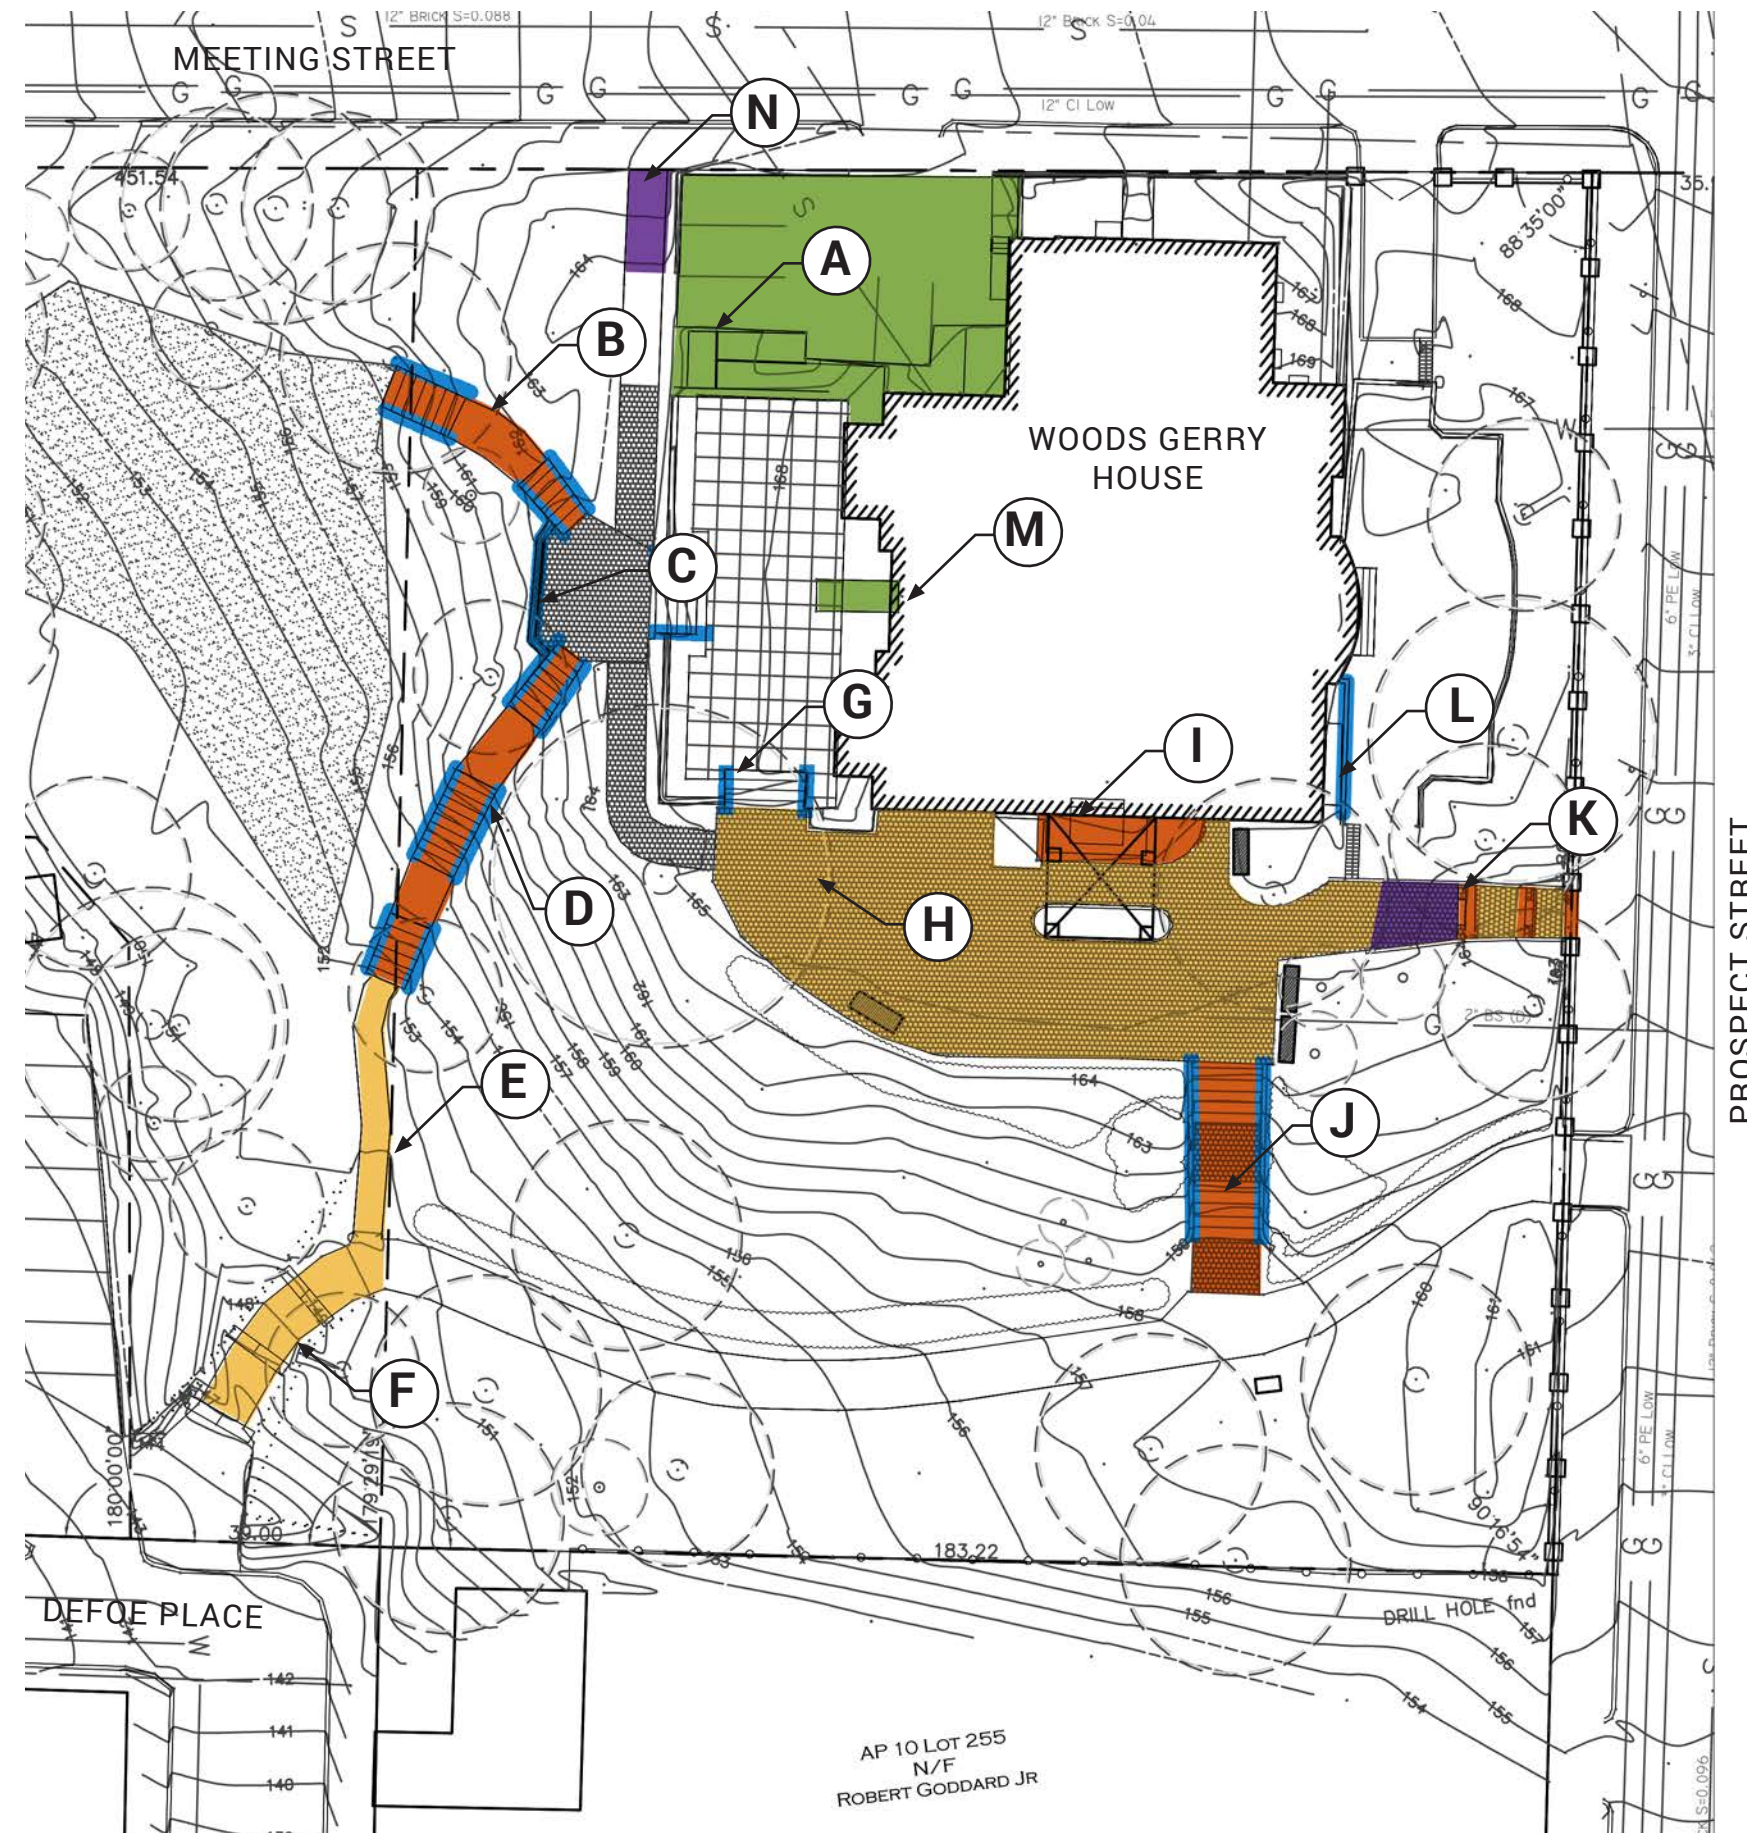
PHYSICAL SAFETY ISSUES

D Dangerous edge condition.

J Brownstone stairs are deteriorating

K Small uneven stairs pose tripping hazard. Too steep at top.
